Forging Press

ILC Assignment:

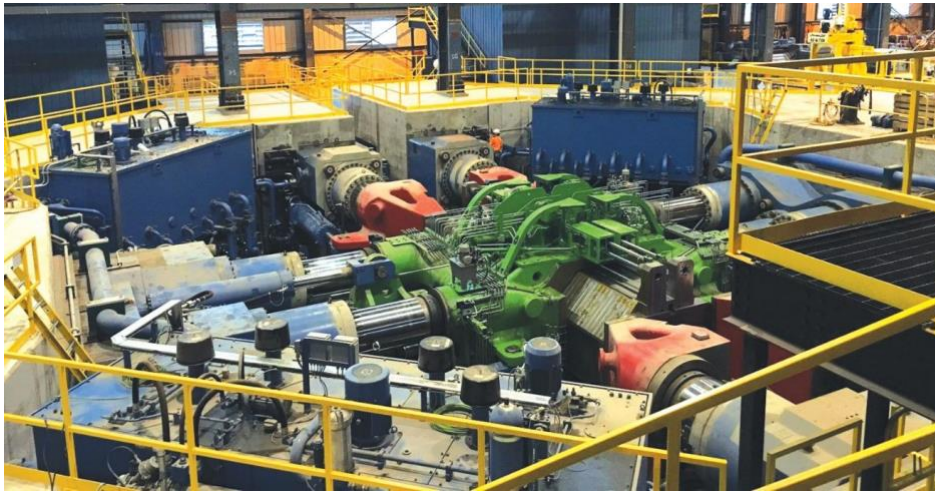
- The surface anomalies had not caused any observable, large-scale hydraulic leaks at the time of our inspection, but were the cause of concern.
- ILC identified roof leaks that allowed stormwater to enter the building and contact forging press cylinders.
- The forging press is located in a non-climate controlled industrial building.
- Weather history available from the National Weather Service indicated that since installation, the period before the corrosion appeared had the lowest recorded temperatures in the year and largest changes in low to high temperatures for a given day.

- Based on the investigation, the surface anomalies were caused by moisture, two sources, roof leaks, and condensation.
- Press manufacturing error eliminated as a cause, absolving client and their insurer of liability
- Recommended mapping and monitoring the cylinder condition for changes in manifestation and severity before proceeding with any cylinder repairs since the current anomalies were not affecting the hydraulic seals to the point of allowing large-scale hydraulic system leaks.
