FLOOD/WATER DAMAGE

FIRE PUMP SYSTEM & AUTOMATIC TRANSFER SWITCH

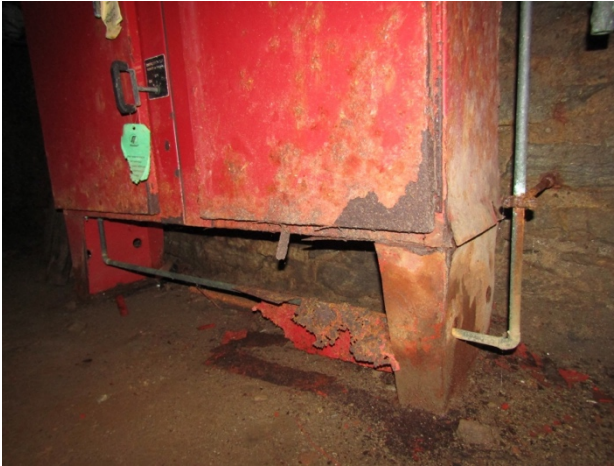
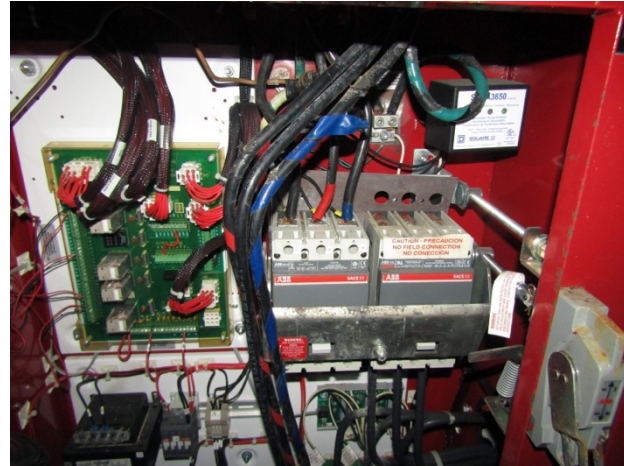
- The insured reported that the corrosion was caused by water contamination from the flood.
- During ILC's examination, we noted that moisture was present on the walls, however, the basement lacked evidence of a flood like a watermark.

- Confirming corrosion on the top and base of the fire pump controller and ATS enclosures during the fire pump system inspection.
- Noting deterioration of conduit and electrical supply meter due to corrosion in the fire pump equipment.
- Inspecting the interior of the enclosure, finding no corrosion on internal electronics, and no evidence of water contamination.
- Verifying operational status of the pump controller and ATS during the site inspection.
- Attributing the corrosion to normally occurring moisture in the basement over time, rather than a flood event.
- Validating reasonable repair proposals from multiple vendors, ensuring the use of Like, Kind, and Quality equipment.
- Successfully reducing electrical supply repair cost by \$3,635 with a repair quote obtained from the fire system vendor.
