MECHANICAL FAILURES

HORIZONTAL GRINDER

ILC ASSIGNMENT:

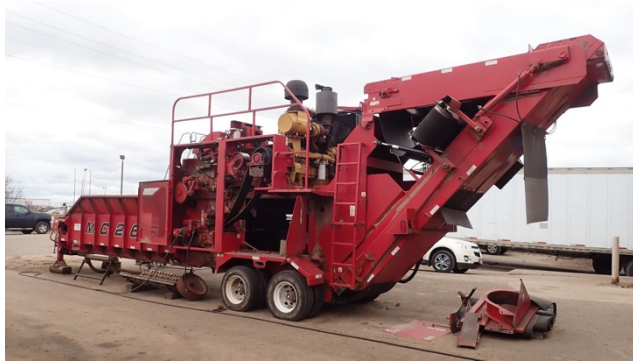
- The grinder was utilized for wood pulverization.
- A few months after its new purchase, the grinder experienced multiple mechanical failures, necessitating significant service part replacements.
- Following the part replacements, persistent breakdowns continued to occur.
- Approximately \$100,000 was expended on service parts and repairs to maintain grinder functionality.
- Three years after its new purchase, the insured concluded that the chopper had experienced a nearly catastrophic failure, rendering it inoperable.

- The extensive list of grinder failures stemmed from sustained operation with severe vibrations caused by an inadequately repaired main rotor. The rotor had been operating out of dynamic balance since the initial failure of the rotor tooth mount.
- **ILC determined that the recent grinder failure was a consequence of improper repairs, inadequate and untimely maintenance, and user misuse.**
- We assessed that replacement of the machine was unnecessary to restore proper operation.
- The essential repairs, totaling \$125,967, were necessitated by the prolonged operation of a machine that had been repaired without adherence to industry-accepted practices or support from the original equipment manufacturer.
