# PROJECT RECAP

## DAMAGED CAR WASH SYSTEMS

A Detailed Review of Car Wash Equipment Loss and Replacement saved our client \$32,000.

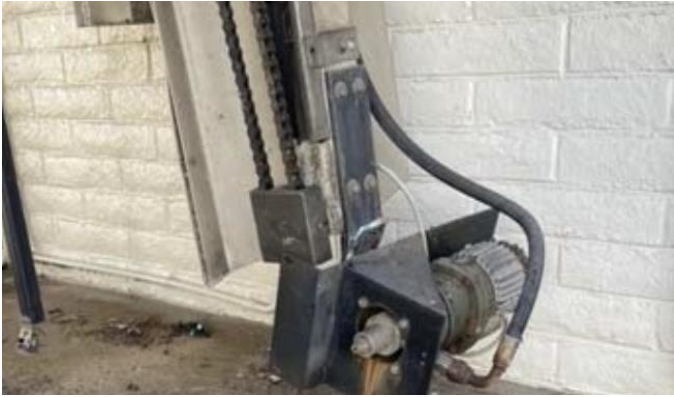
Evidence of vehicle impacting the Gantry.

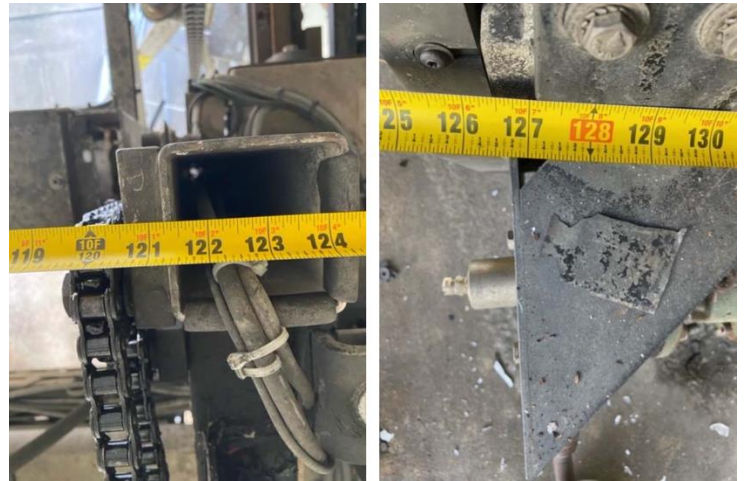
Due to the impact, the Gantry Frame Assembly has been stressed beyond its design. The Gantry Frame Assembly has been bent several inches from the top of the structure to the bottom as pictured above.
