PROJECT RECAP

MAJOR CORROSION

HVAC

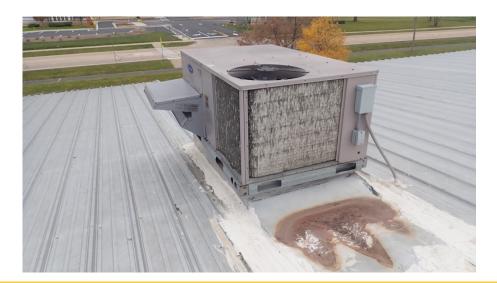
- At the time of the site visit, we observed a multi-unit commercial building with three independent HVAC units.
- It was identified and documented damages to the three independent systems including clogged air filters and major corrosion.

- While the insured believed the inoperable HVAC unit was a result of exposure to rainwater due to a missing service access cover, ILC determined that the extent of severe corrosion damage was a result of continued operation with failed components.
- After correspondence with the OEM, it was determined the best means of returning the insured to operation quickly and cost-effectively was with a replacement quoted for \$7,850.
