PROJECT RECAP

DAMAGED DURING TRANSIT

CORRUGATED BOX MAKING MACHINE

Transportation Damage to Industrial Equipment

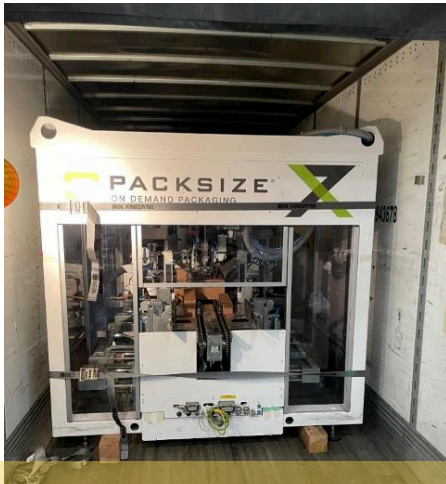
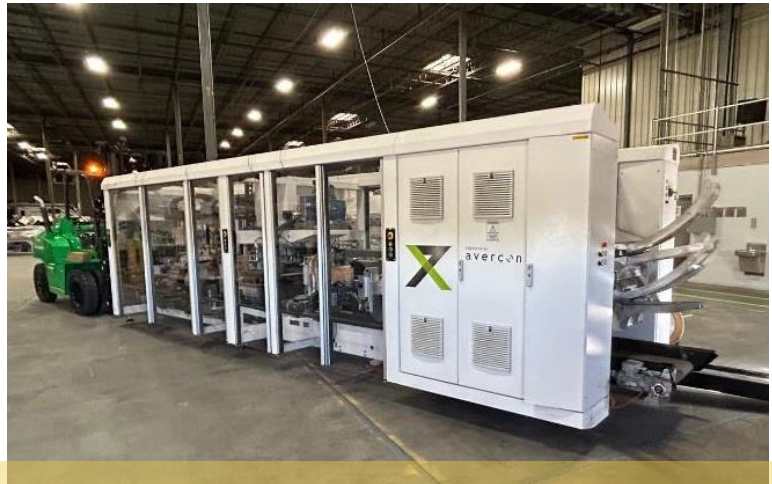
A two-year-old corrugated box-making system was reportedly damaged during transit by truck. The objective from the client was to assess the extent of the damage and investigate the cause of the loss.
