Rooftop HVAC Loss

ILC Assignment:

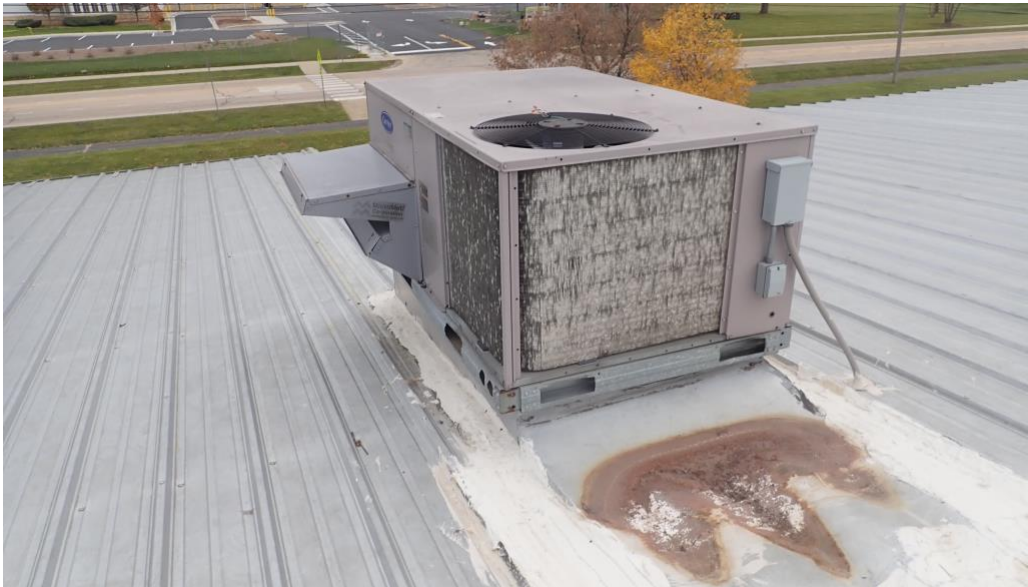
- At the time of the site visit, ILC observed a multi-unit commercial building with three independent HVAC units.
- ILC identified and documented damages to the three independent systems including, clogged air filters and major corrosion.

- While the insured believed the inoperable HVAC unit was a result of exposure to rainwater due to a missing service access cover, ILC determined that the extent of severe corrosion damage was a result of continued operation with failed components.
- After correspondence with the OEM, ILC determined the best means of returning the insured to operation quickly and cost-effectively was with a replacement quoted for \$7,850.
