CNC Machine Breakdown

ILC Assignment:

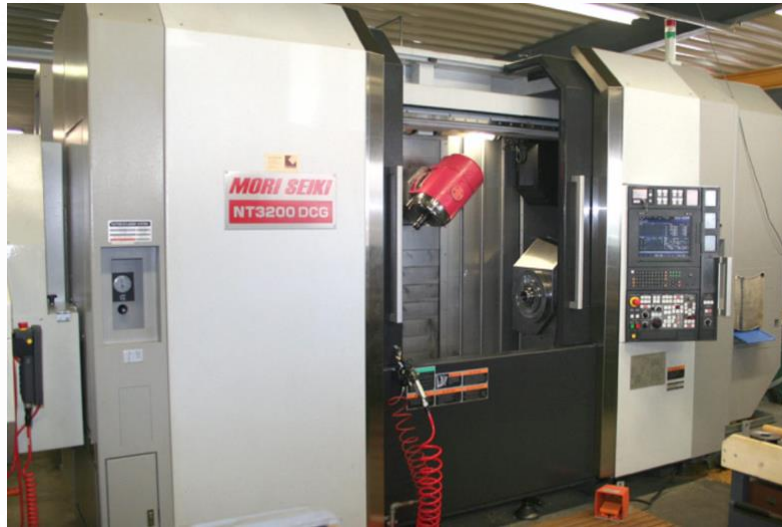
- ILC thoroughly inspected the machine to determine if it was restorable to pre-loss condition.
- ILC reviewed the new replacement quote of \$750,000 provided by the insured.
- ILC noted damage to the CNC spindle.

- The loss was caused by an operator error where the spindle crashed into the X-axis, not a defect on the machine.
- ILC determined the machine loss was feasible to restore to pre-loss condition.
- ILC provided an ACV valuation of the equipment.
- ILC obtained a repair quote that was \$616,000 less than the insured supplied replacement quote.
- ILC believes that once the B-axis is replaced and the geometry is adjusted the machine will be back to pre-loss condition and functionality.
