DETERMINING IF A LOSS IS A REPAIR VS. A REPLACE SOLUTION

A FASTER, SAFER ROUTE BACK TO PRODUCTION WITH HUGE COST SAVINGS

SATURATOR CONVERTING LINE

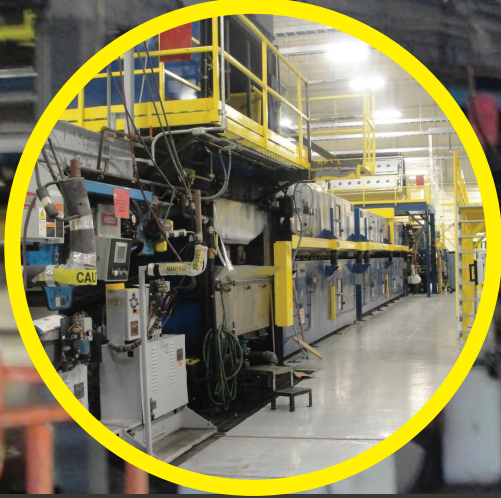
An explosion occurred within a curing station inside a production line built to produce a 90-100” foam board for finishing. Production required high volume, continuous delivery. The curing station included a gas-fired steam dryer. Business Interruption was estimated at a rate of \$1.6 million per month, and options were limited for outsourcing production short term.

The Original Equipment Manufacturer (OEM) was no longer in business and the entire line lacked documentation. Upon inspecting the curing station, ILC consultants determined the station to be “unsafe and inappropriate” for repair. Replacement of the entire line with Like, Kind, and Quality (LKQ) parts was estimated to take up to 16 months at an approximate cost of five million dollars.

ILC provided an assessment within seven days that included a comprehensive evaluation of the entire warehouse, production line, and employee workspace. ILC recommended rebuilding what could be salvaged from the line and integrating a safer solution for the steam dryer. This approach allowed Like and Kind quality production with a different dryer which was safer and easier to maintain than the original dryer. The cost to rebuild and replace was \$3.25M and ILC's consultants oversaw the process integrating multiple mechanics, engineers, and crews to restore full production within six months.

- A credible plan for restoration to pre-loss production capacity utilizing a different method of curing the product in the form of a used Hot Air Flotation Drying System.
- The solution provided by ILC helped to **save the client almost 12 million dollars in Business Interruption expenses** and avoided the timely process required to replace the entire line.
- ILC Project Managed all aspects of the job communication with both the insured and the third-party adjusting firm which helped to streamline the communication between all parties.
