CORROSION

VULCANIZING PRESSURE VESSELS

ILC ASSIGNMENT:

Identified the cause and extent of damage and confirmed the costs associated with the replacement of two vulcanizing pressure vessels used to vulcanize rubber hose materials.

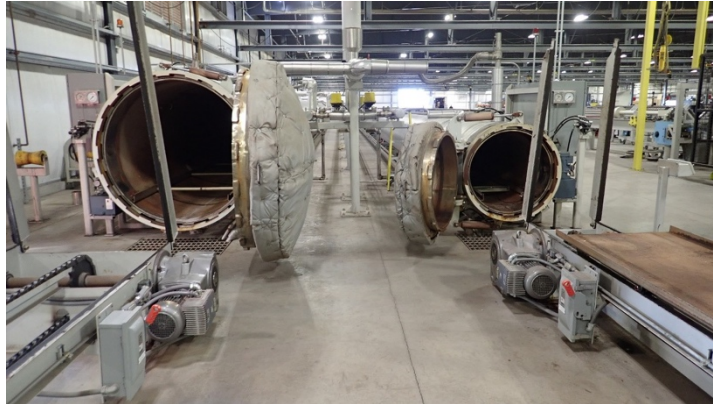
- The insured's personnel discovered that corrosion had caused the breakage of stainless-steel steam injection/water cooling piping within one of the 2 vessels.
- Upon closer inspection by personnel, both vulcanizing pressure vessels were found to exhibit cracks in multiple locations.
- The insured used water to cool the vessels/product to expedite production.
- Tests performed on the cooling water revealed the presence of chloride contamination.

- It was concluded that the stainless steel, which generally does not corrode to the observed magnitude, composing the vulcanizing pressure vessels was adversely affected by the high concentrations of chloride in the cooling water.
- The corrosion and crack development within the vessels were consistent with the culmination of long-term conditions and inconsistent with a sudden and incidental event.
- ILC confirmed that continued use of the pressure vessels was a safety concern; repair of the pressure vessels was not prudent, and replacement of the pressure vessels was the only way to safely return them to production.
- ILC confirmed the costs of the Ø3' pressure vessel at \$468,797 and the Ø5' pressure vessel at \$681,500.
