PROJECT RECAP

FLOOD LOSS

INDOOR WATER PARK

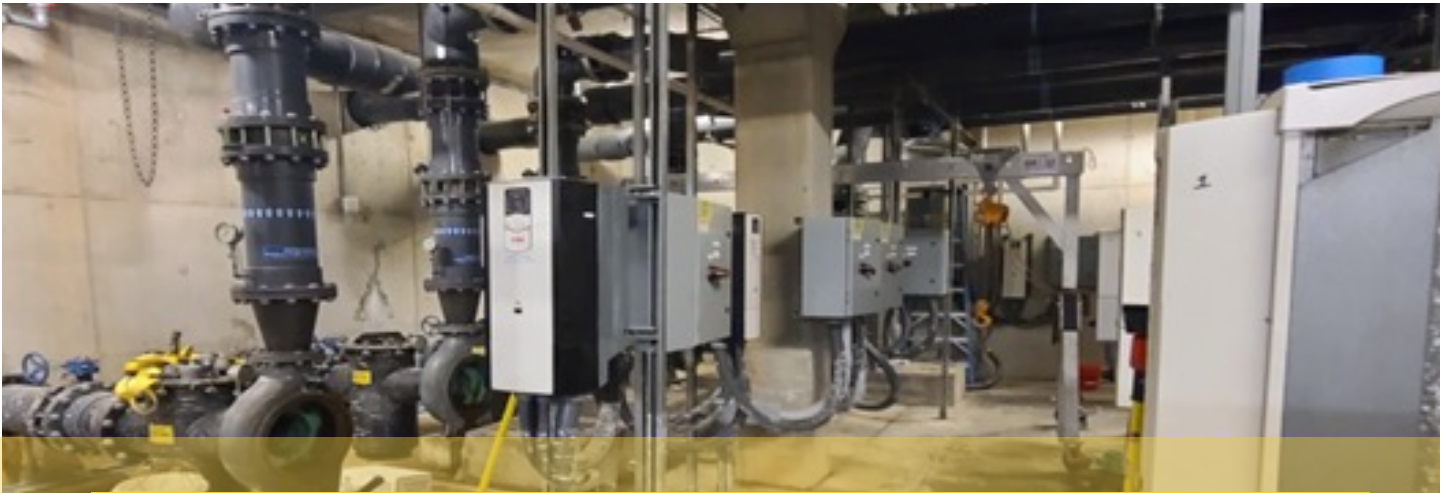
As a result of ILC accessing the site immediately after the flood, our consultants were able to identify the damaged electrical distribution equipment.

Corrosion on electrical distribution equipment was identified above the high-water line predating the most recent flood event.

The identified corrosion was attributed to the prevailing working environment, specifically chlorine vapors in the mechanical and electrical rooms.

ILC learned that the electrical repair contractor provided a \$500,000 quote to replace all electrical equipment where corrosion was evident, regardless of whether the corrosion occurred before or after the most recent flood event.

Leveraging ILC's identification and documentation of the pre-existing conditions throughout the water park, the restoration costs attributed to the flood event were **successfully REDUCED to \$90,000.**
